ADEQ Final Determination (1980's Rule), - Alvord Park Lake AZL15060106B-0050

ADEQ Final Determination (1980's Rule), - Big Creek AZ15050201-312

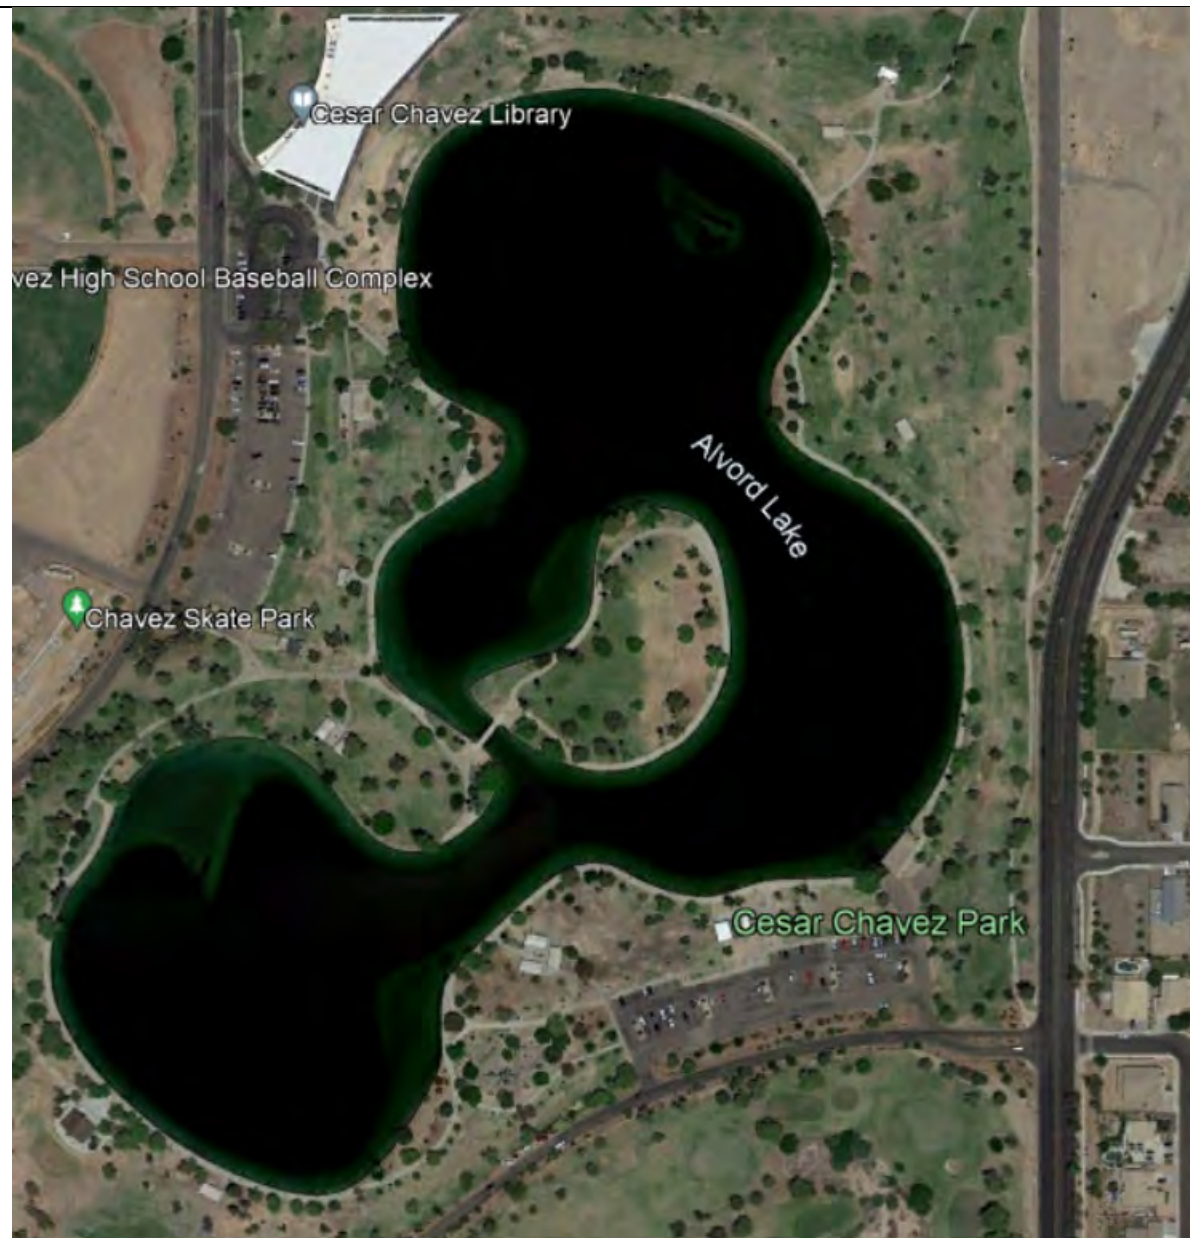
Figure 1: Alvor Park Lake is an urban lake with no outlets and is concrete lined.

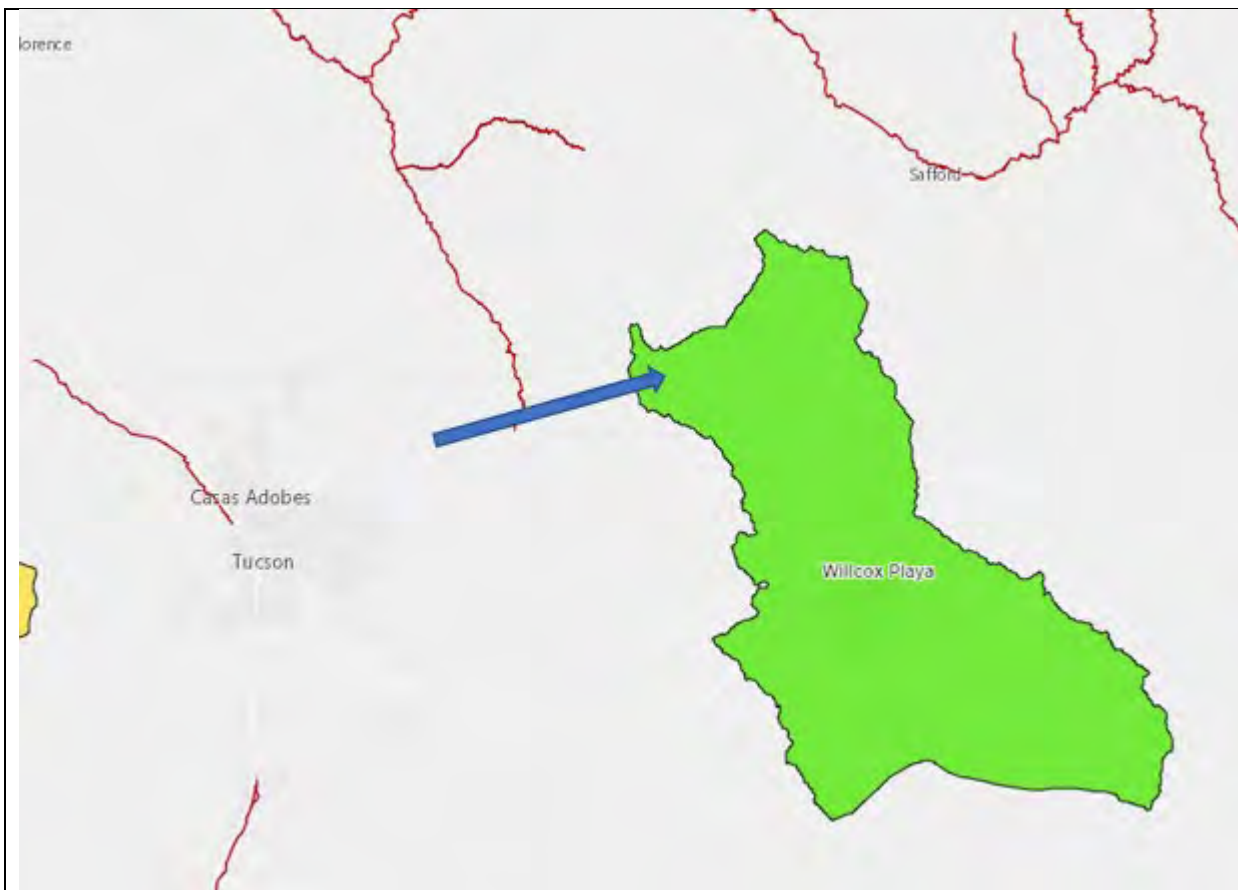
Figure 1. A WOTUS Webmap image showing that Bull Tank AZL15050201-0220A, pointed out by the blue arrow, lies within the Wilcox Playa terminal basin.

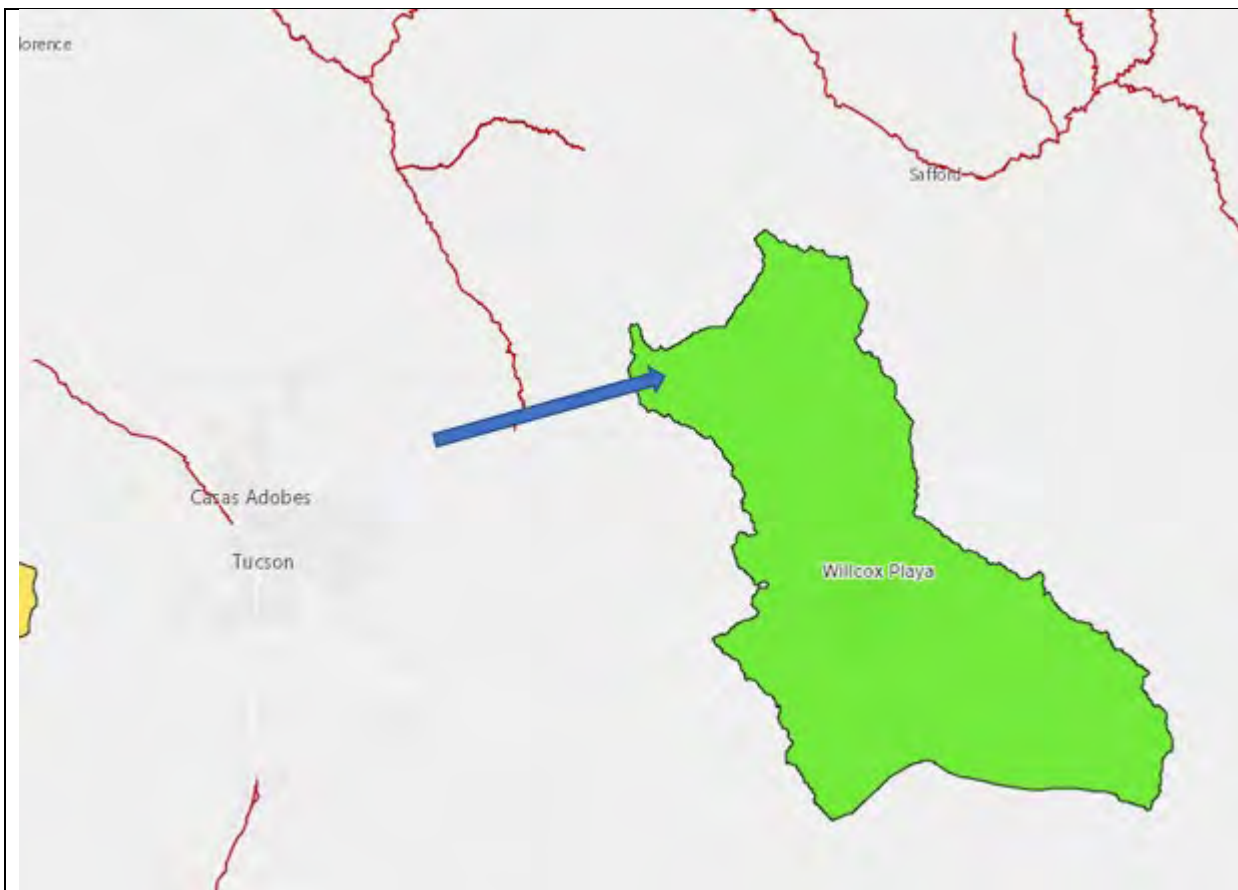
Figure 1. A WOTUS Webmap image showing that Bull Tank AZL15050201-0220B, pointed out by the blue arrow, lies within the Wilcox Playa terminal basin.

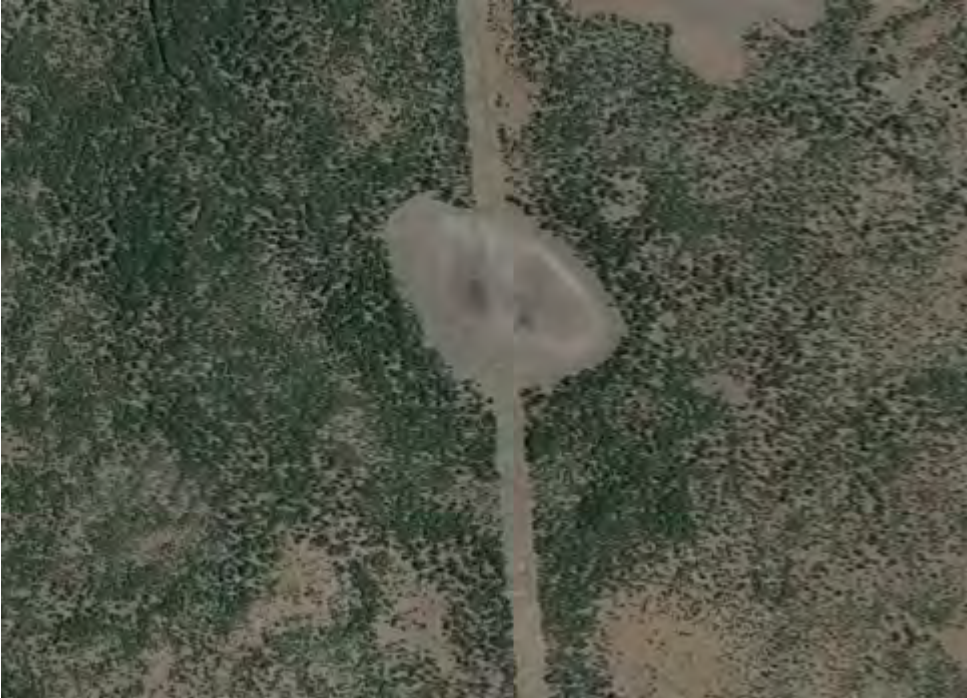
<p>Figure 1. Boot Lake in Google Earth Pro (2021) that shows no outlet from Boot Lake</p>

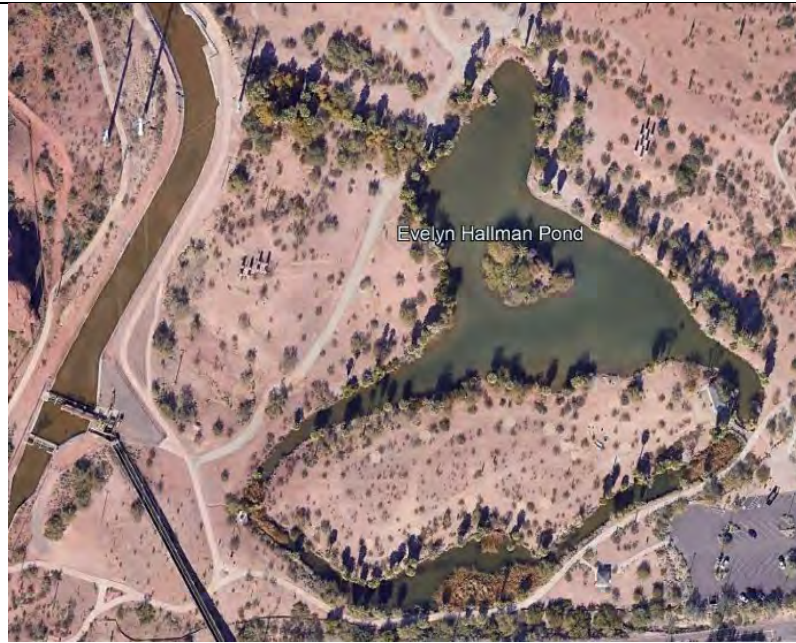
Figure 1. Google Earth Pro imagery (2019) showing Evelyn Hall Pond and no outlet or channel to the Cross Cut Canal to the west.

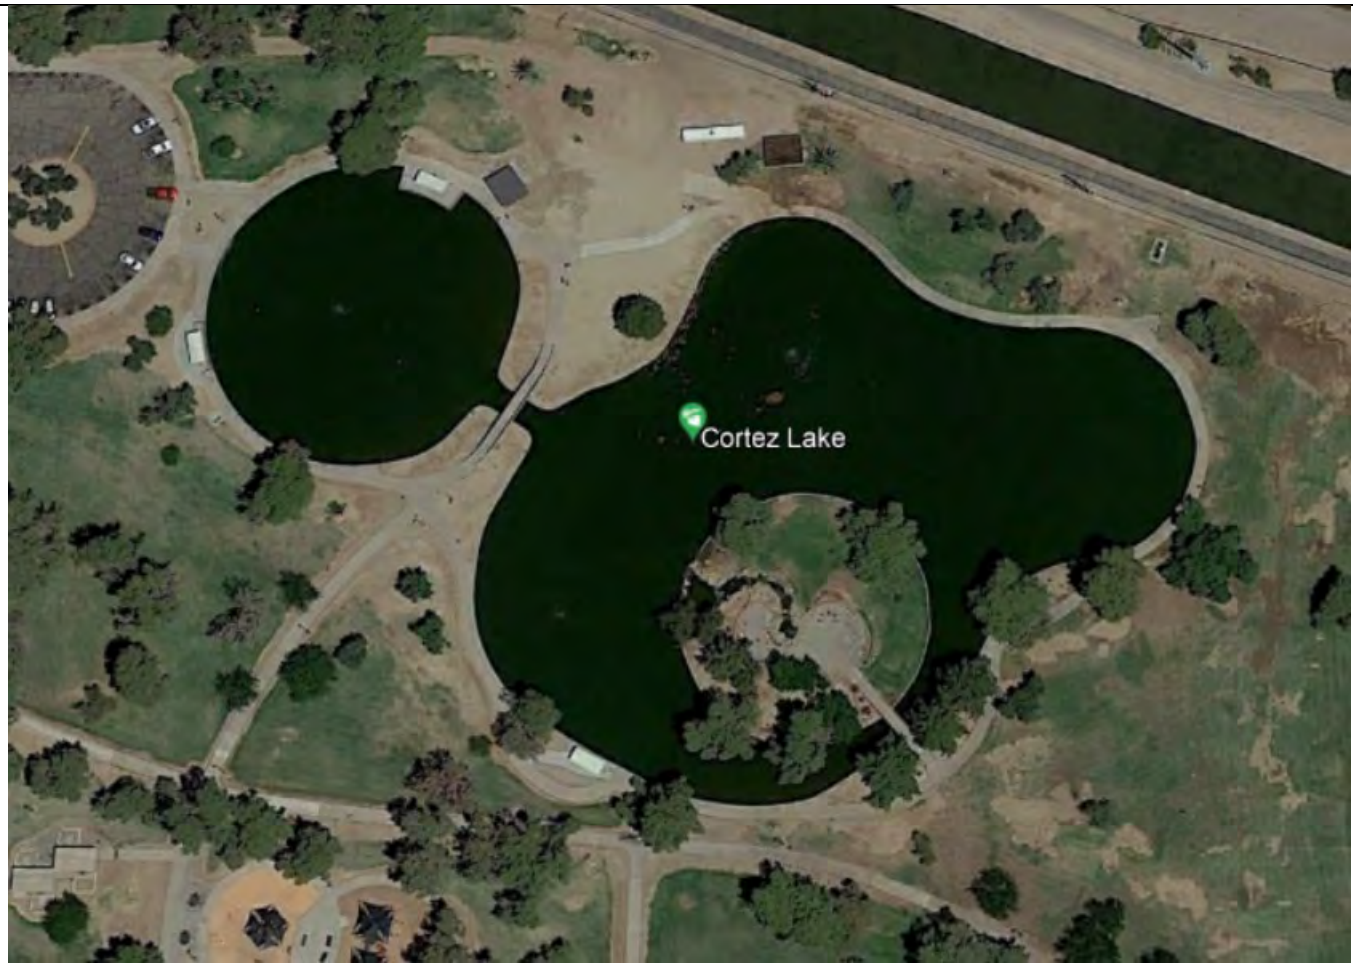
Figure 1: Cortez Park Lake is an urban lake with no outlets and is concrete lined.

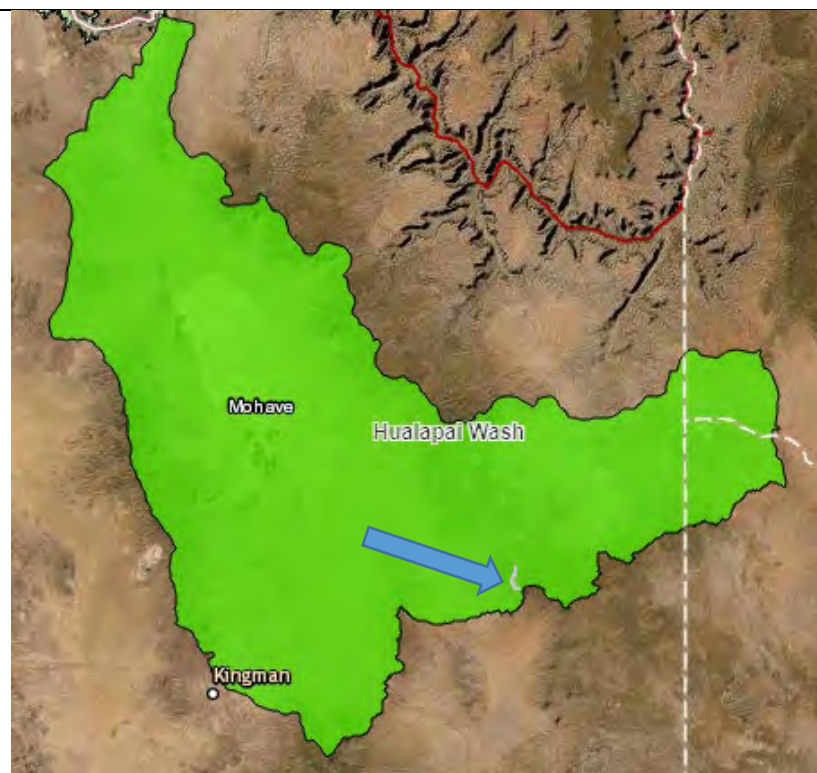
Figure 1. Aerial imagery from the WOTUS Webmap with the Terminal Basins Under the 1980s WOTUS Rule turned on shows that Cottonwood Creek lies within the Hualapai Wash terminal basin.

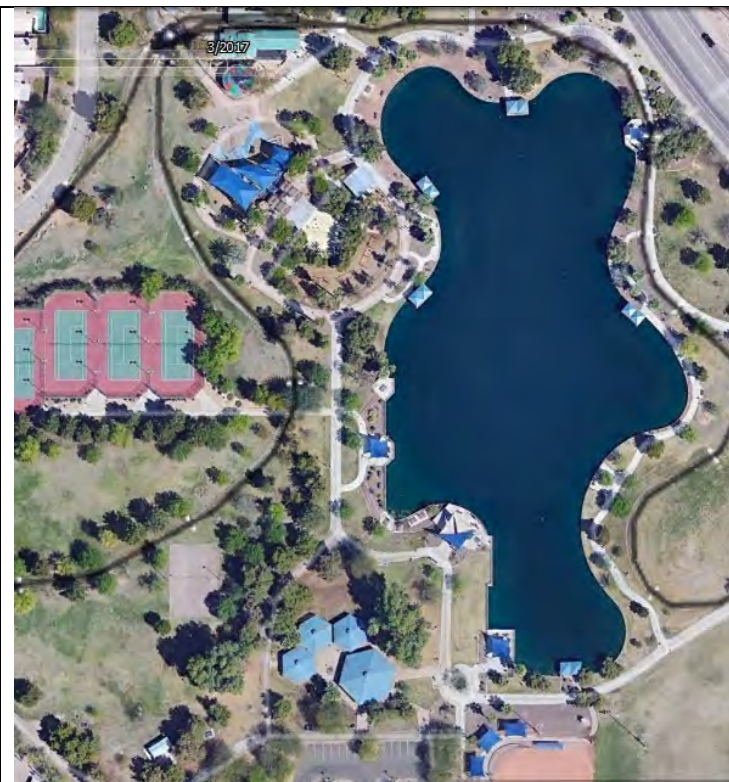
Figure 1. Google Earth Pro imagery (2017) showing Desert Breeze Lake with no outlet.

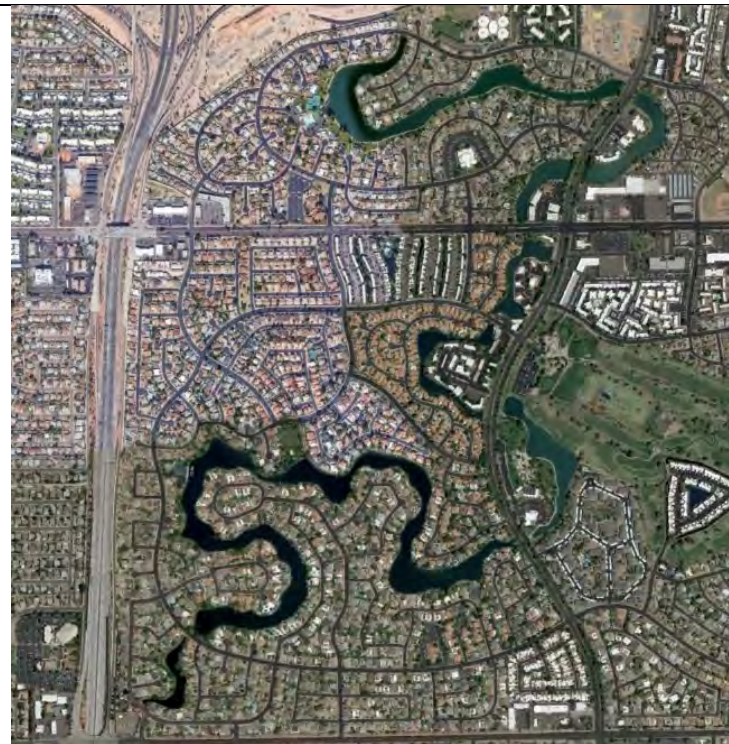
Figure 1. Google Earth Pro Imagery (2021) shows no outlet from the pond.

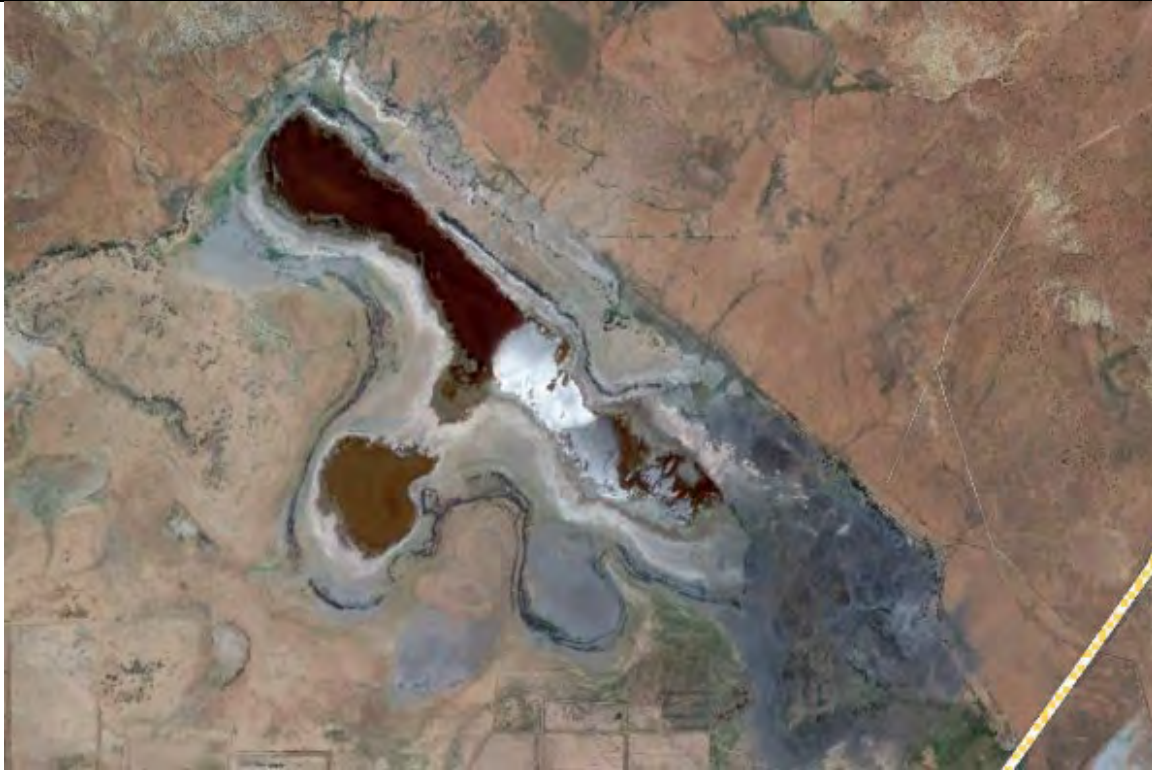
Figure 1. Dry Lake (EDW) is estimated to be intermittent based on aerial imagery and has no visible outlets or channels to downstream waterbodies.

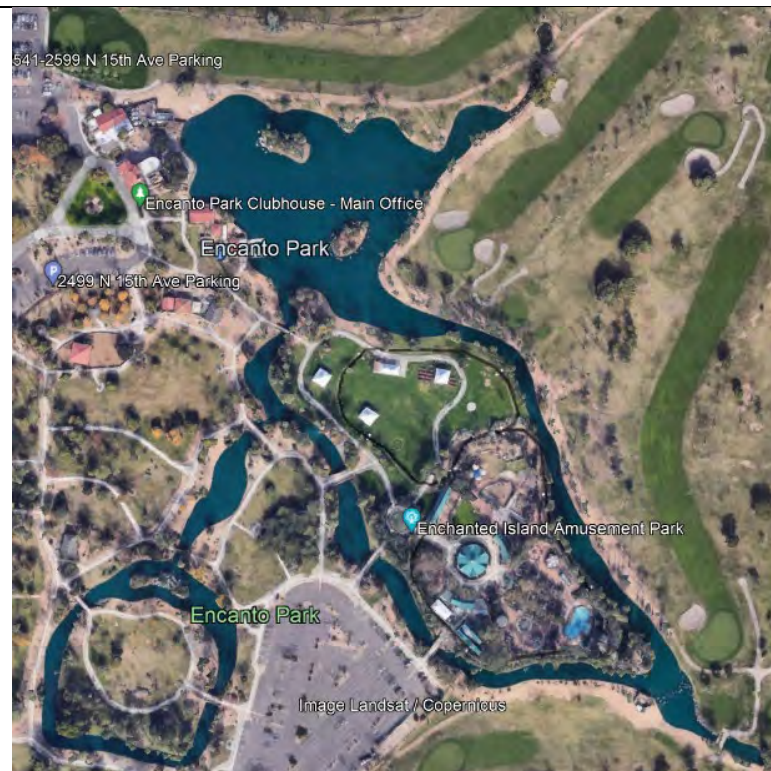
Figure 1. Google Earth Pro imagery (2019) showing Encanto Park Lake and no outlet.

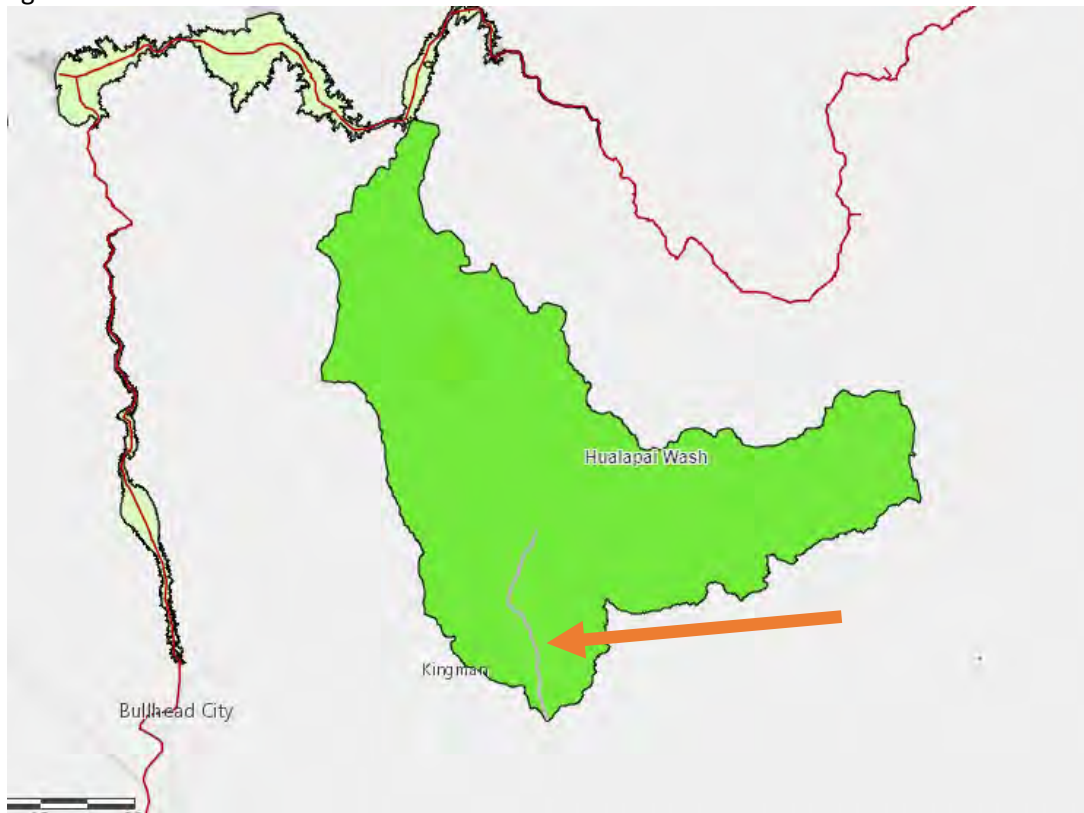
<p>Figure 1: Frees Wash (designated with an arrow) lies entirely in the Hualapai Wash terminal basin.</p>

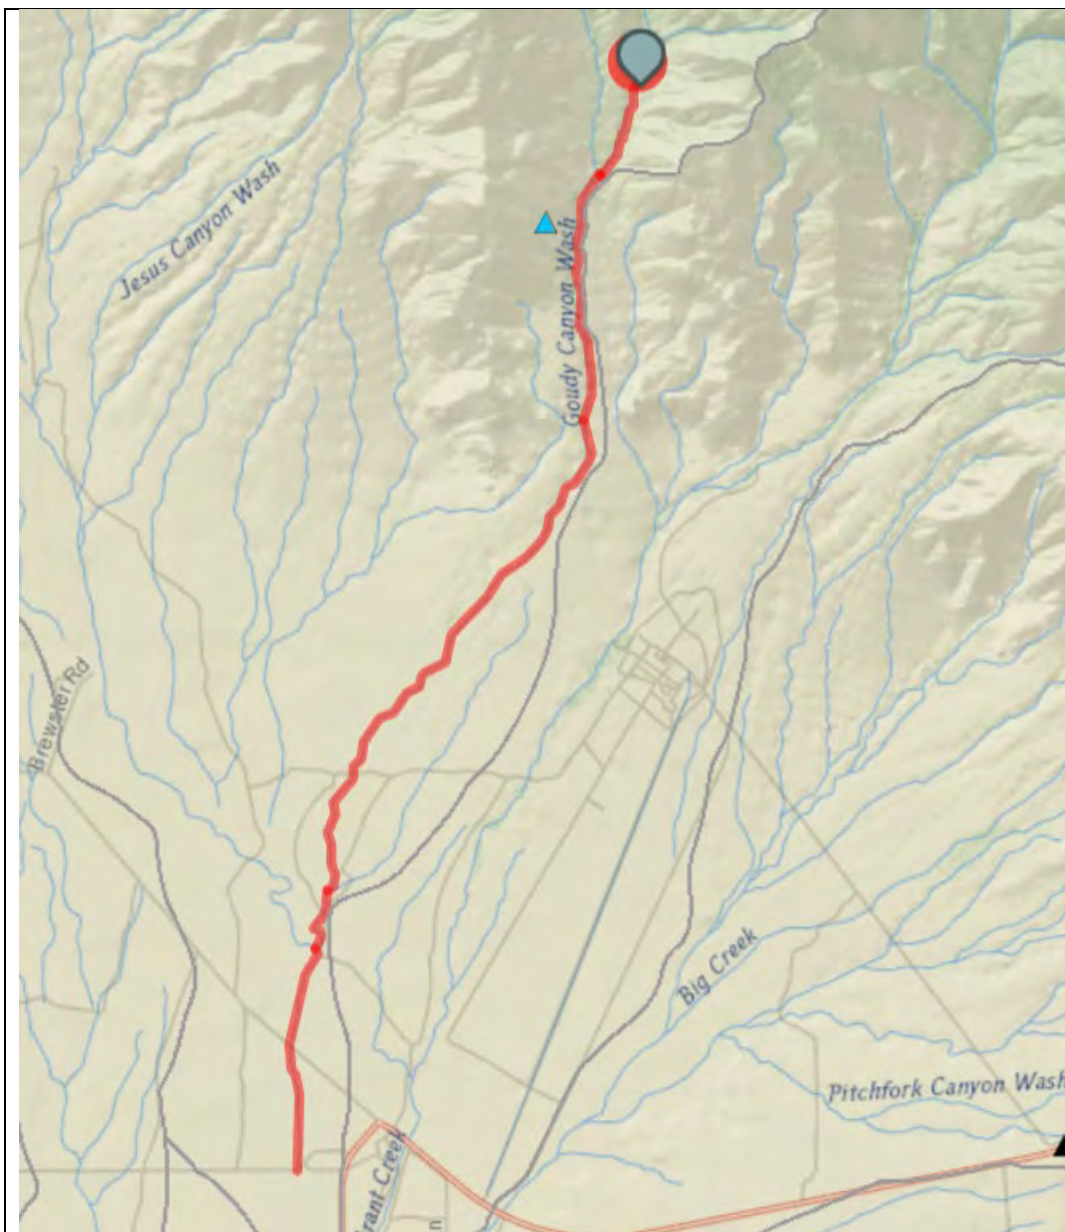
Figure 2. USGS Raindrop tool shows no connection to a TNW and terminates within the greater Willcox Playa Basin.

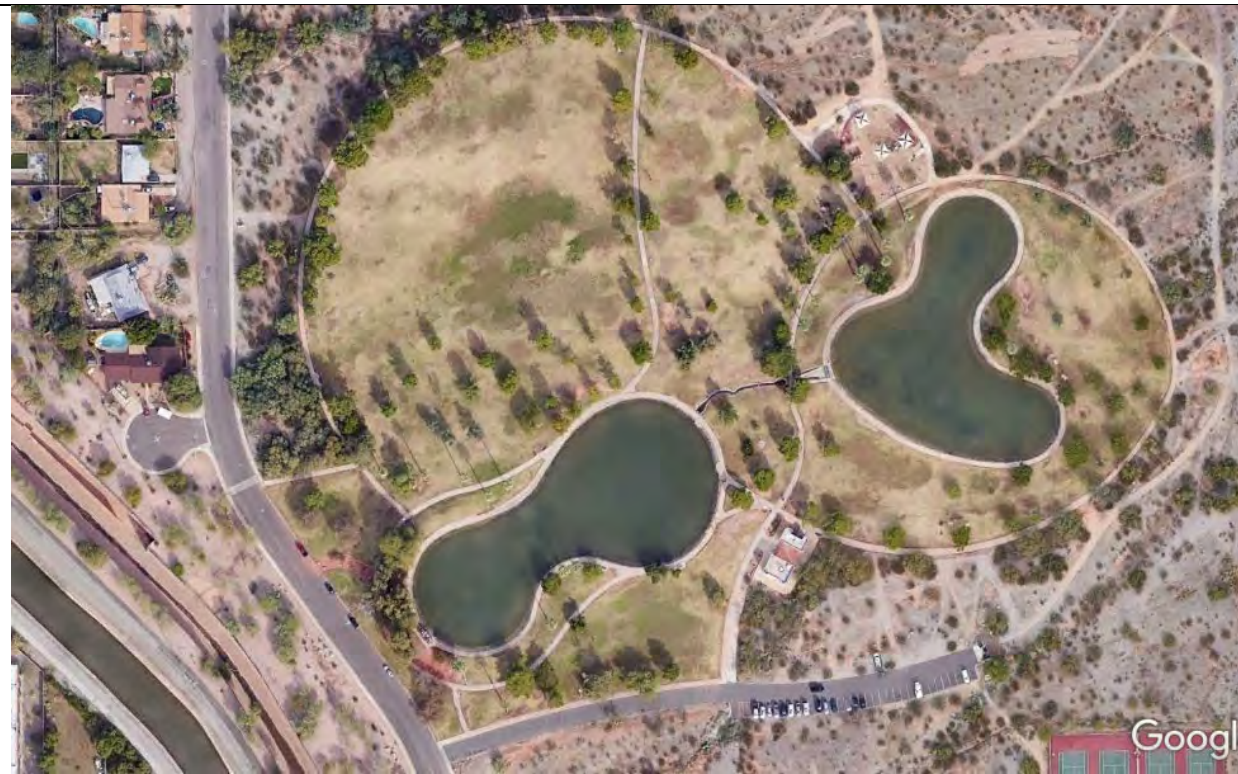
Figure 1. Google Earth imagery of Granada Park Lake. There are no visible outlets present and the perimeter is concrete.

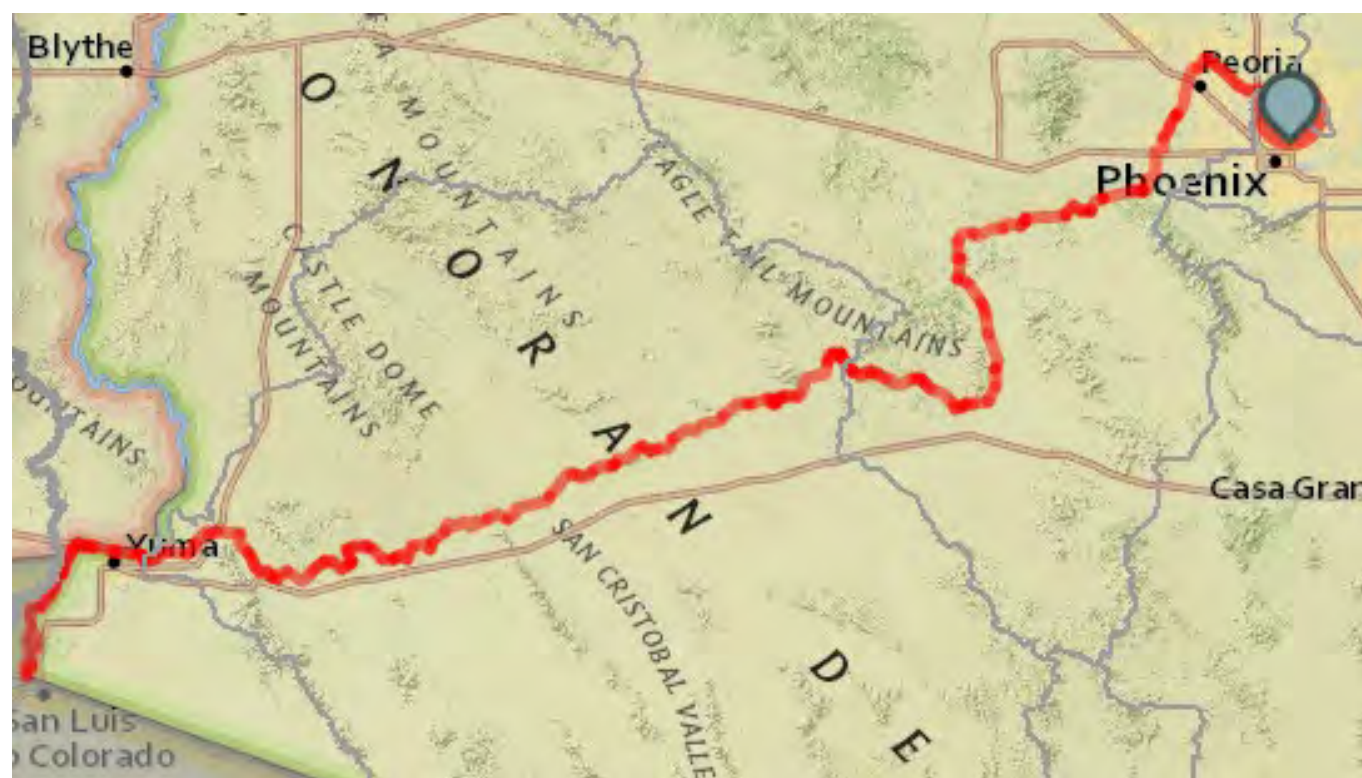
Figure 2b. The USGS Raindrop tool incorrectly shows a flow path from Granada Park Lake to the Gila River TNW.

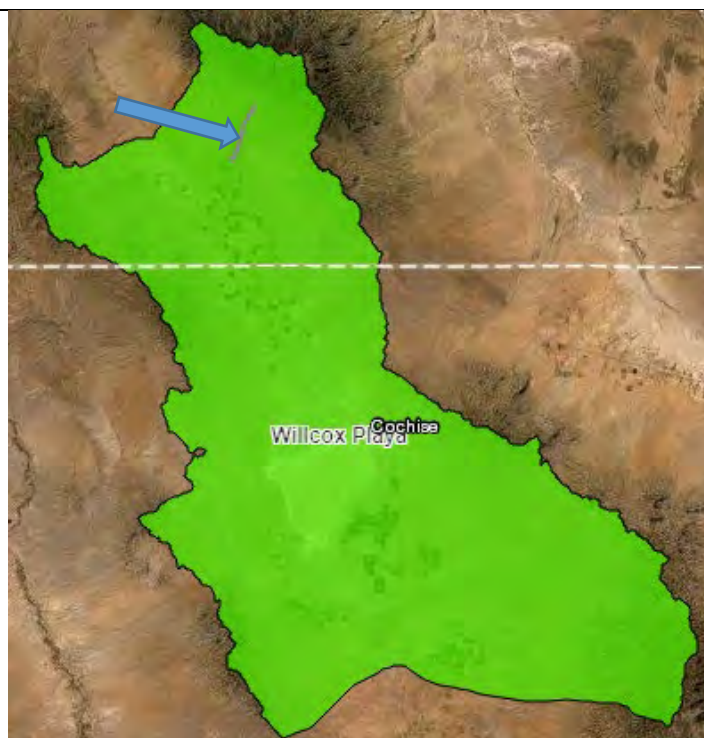
Figure 1. Aerial imagery from the WOTUS Webmap with the Terminal Basins Under the 1980s WOTUS Rule layer turned on shows that Grant Creek lies entirely within the Willcox Playa terminal basin.

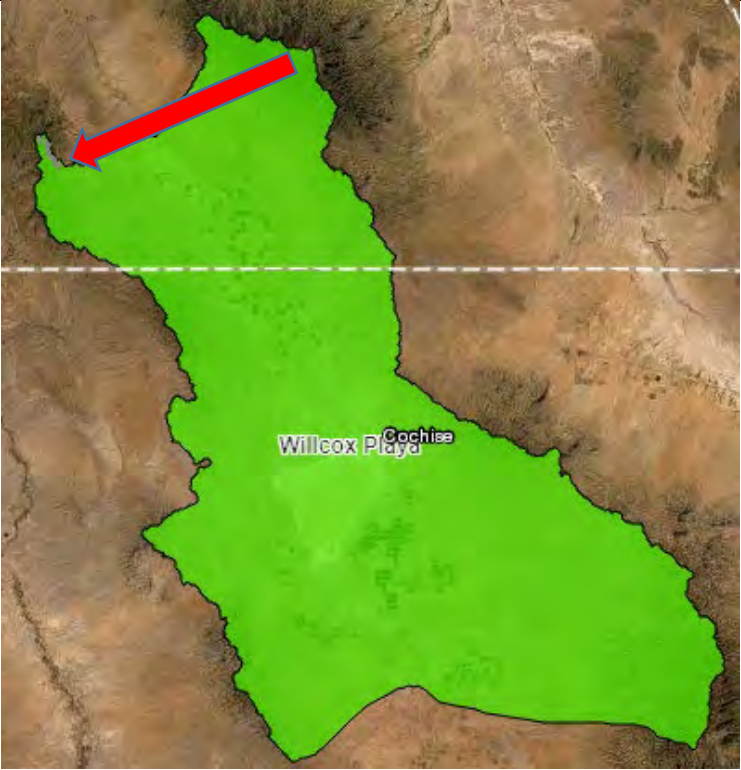
<p>Figure 1. High Creek lies within the Willcox Playa terminal basin (ADEQ WOTUS Webmap)</p>

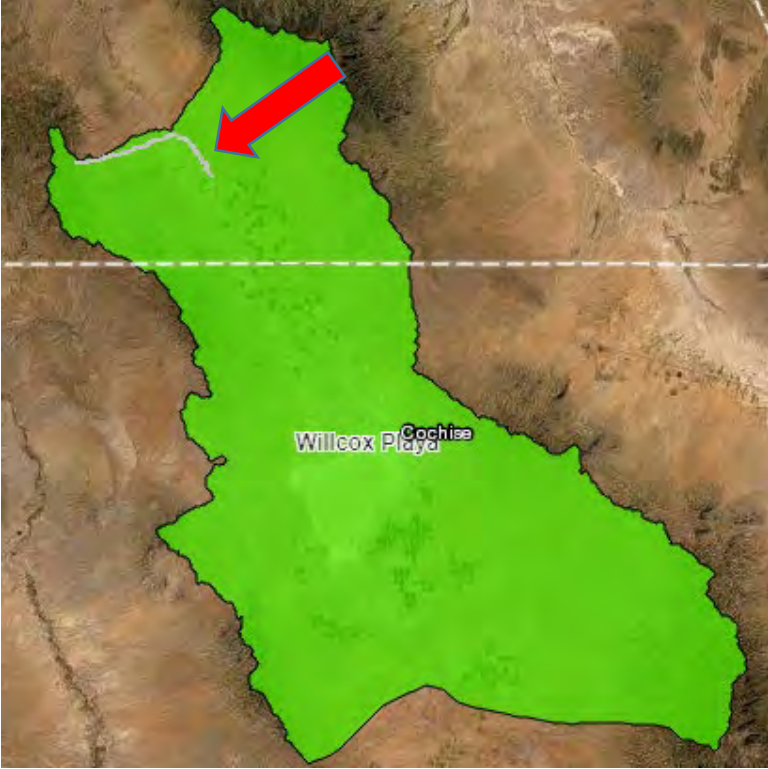
<p>Figure 1. High Creek lies within the Willcox Playa terminal basin (ADEQ WOTUS Webmap)</p>

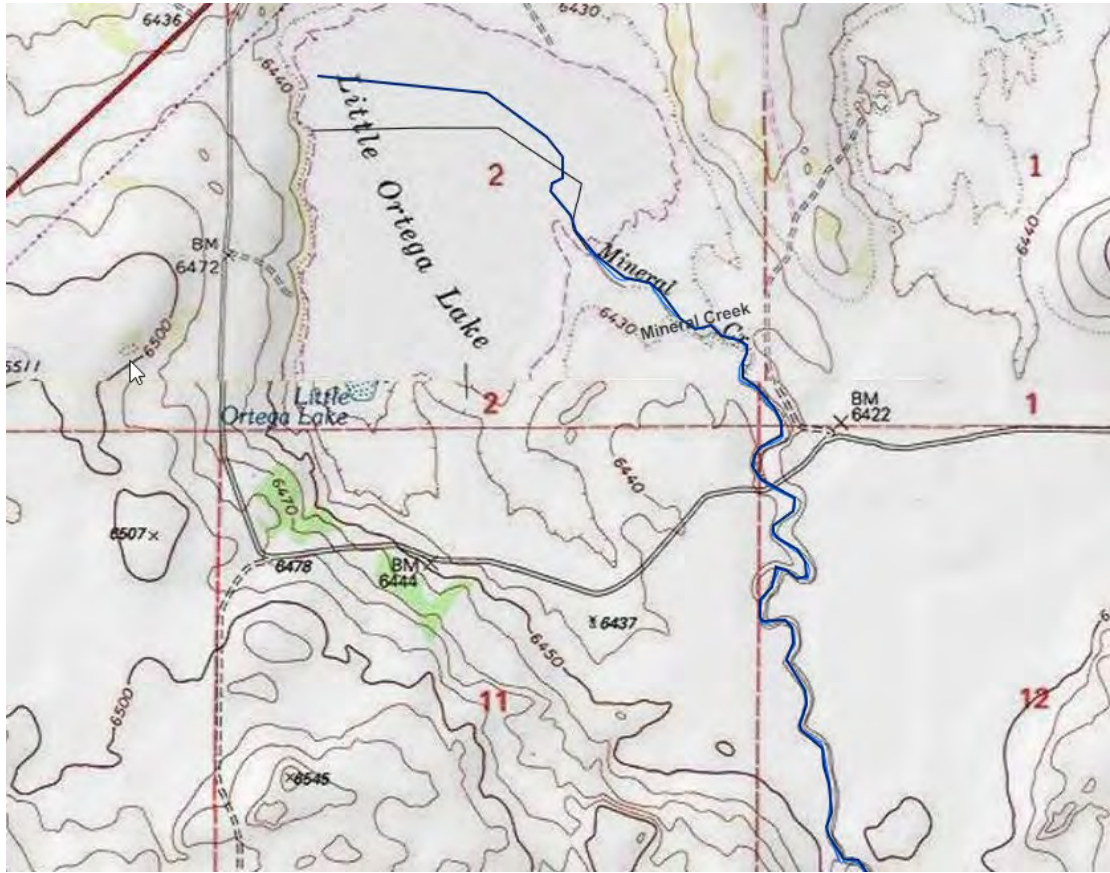
<p>Figure 1: Topo map showing Little Ortega Lake with no outlet channels (Mineral Creek to the southeast is flowing into the lake).</p>

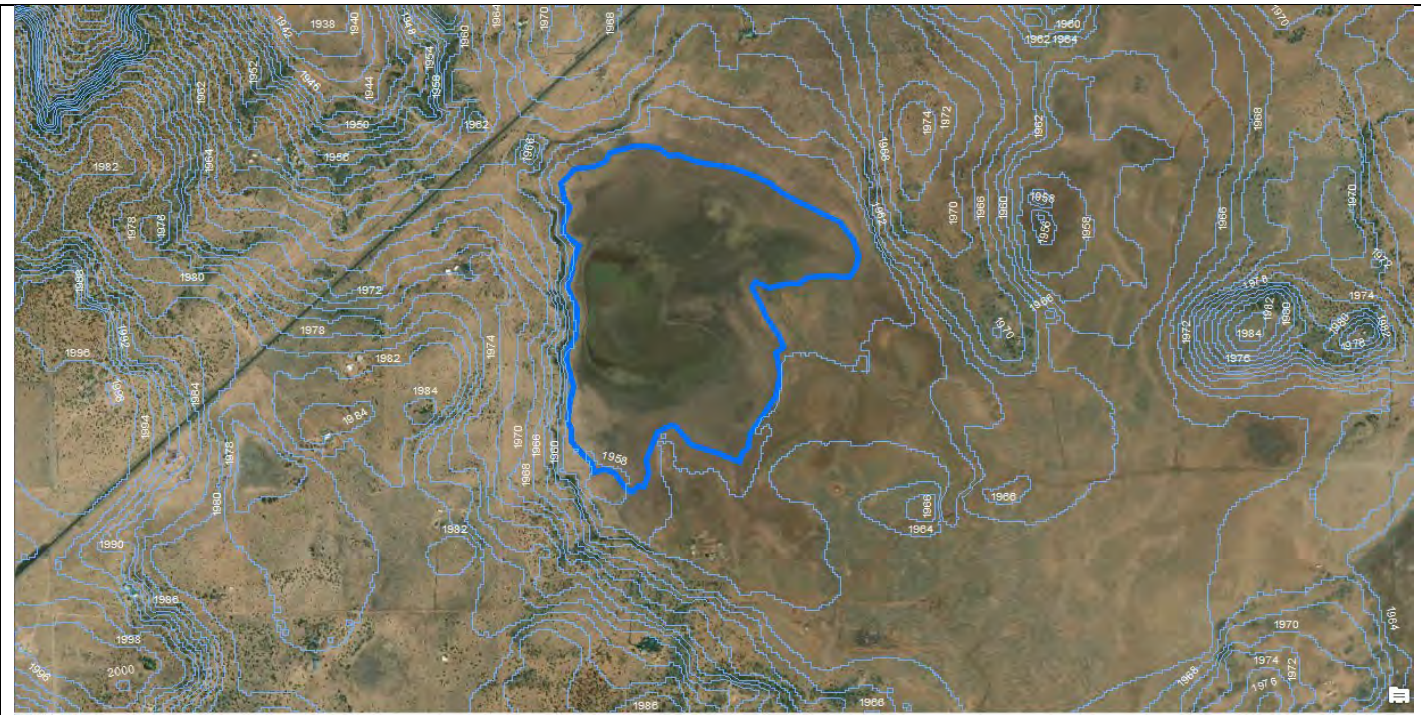
Figure 4: NED 2m contour analysis showing Little Ortega Lake within an isolated, disconnected watershed.

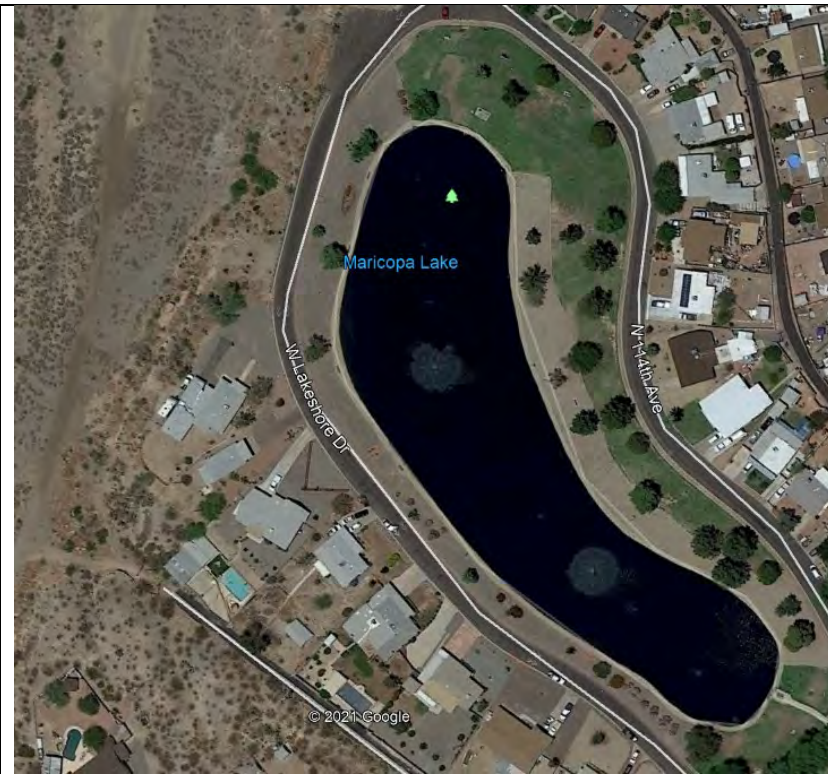
Figure 1. Google Earth Pro Imagery (2021) shows that Maricopa Park Lake is concrete-lined and there are no outlets from the pond.

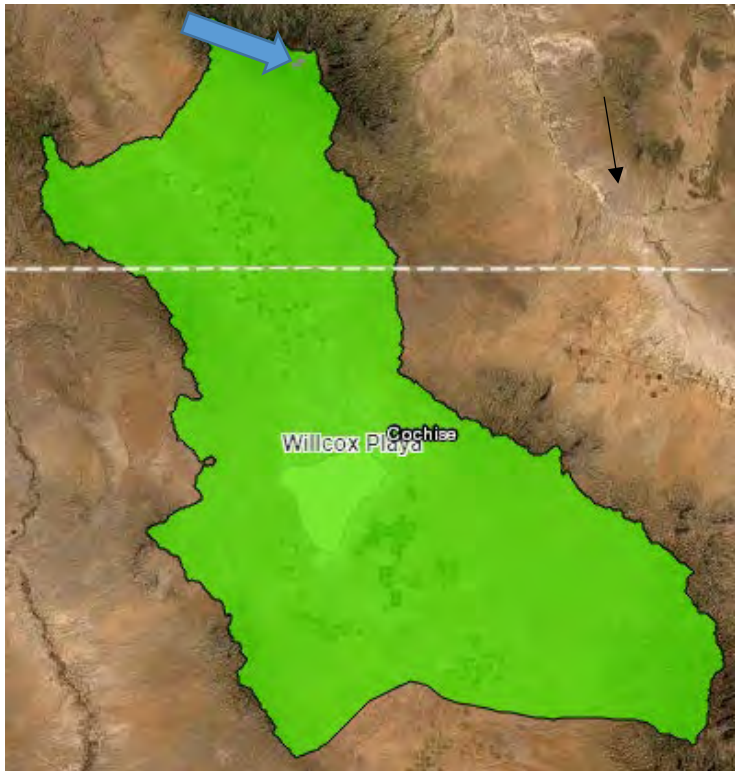
<p>Figure 1. Moonshine Creek (designated with an arrow) lies entirely in the Willcox Playa terminal basin.</p>

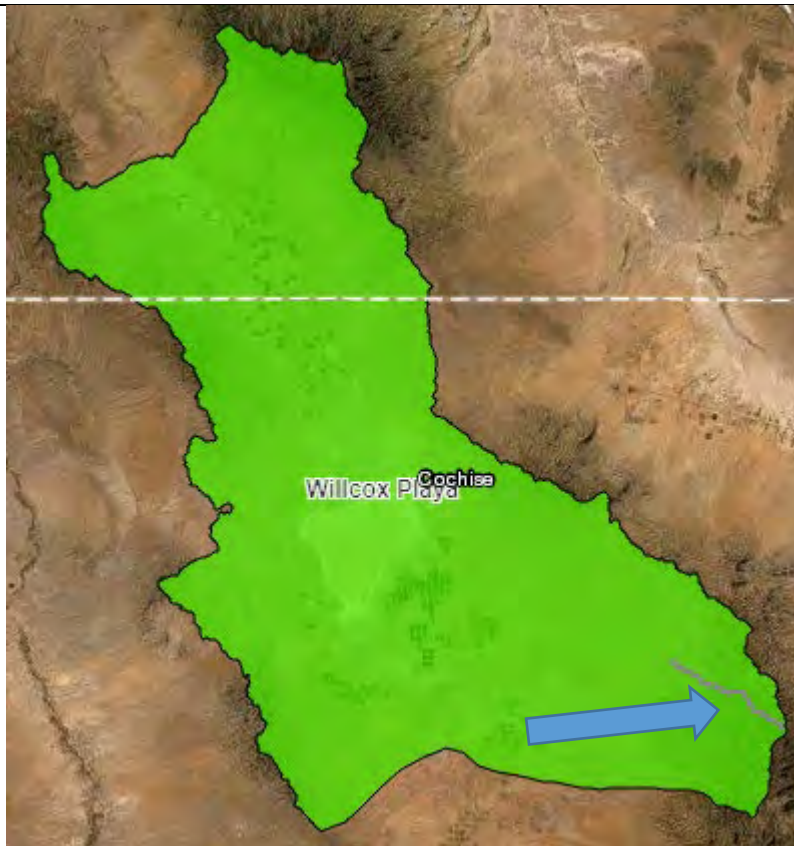
Figure 1. Aerial imagery from the WOTUS Webmap with the Terminal Basins Under the 1980s WOTUS Rule layer turned on shows that Pinery Creek lies entirely within the Willcox Playa terminal basin.

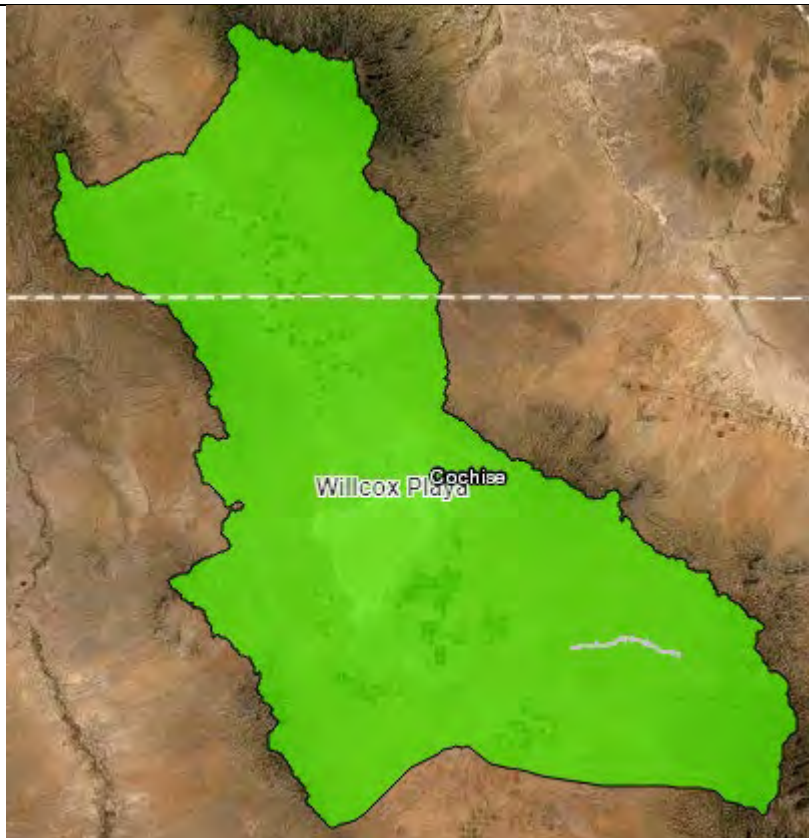
Figure 1. Aerial imagery from the WOTUS Webmap with the Terminal Basins Under the 1980s WOTUS Rule layer turned on shows that Pinery Creek lies entirely within the Willcox Playa terminal basin.

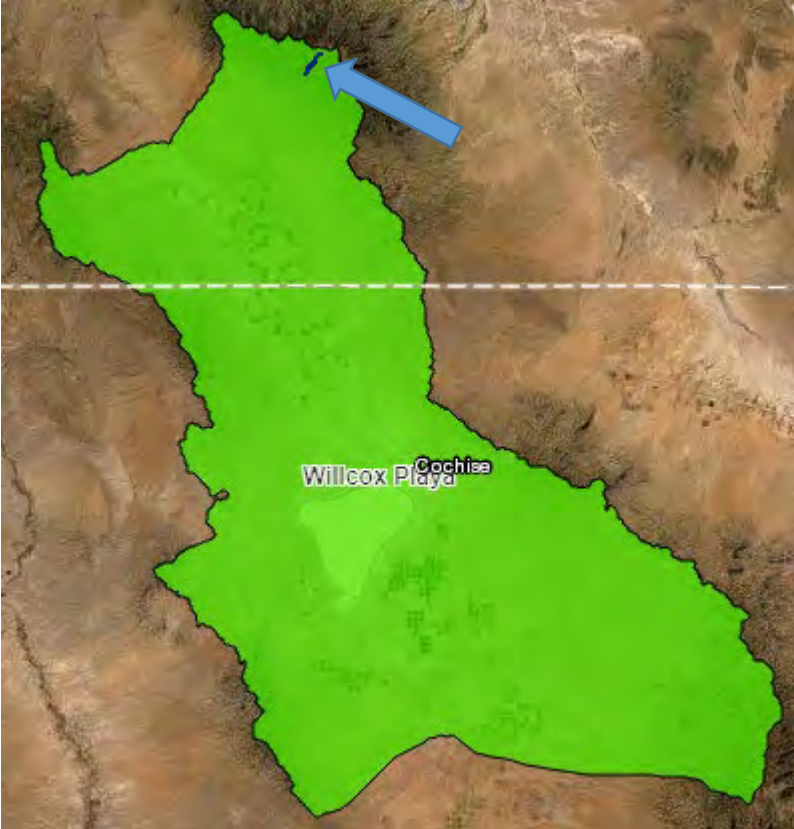
<p>Figure 1. Post Creek (designated with an arrow) lies entirely in the Willcox Playa terminal basin.</p>

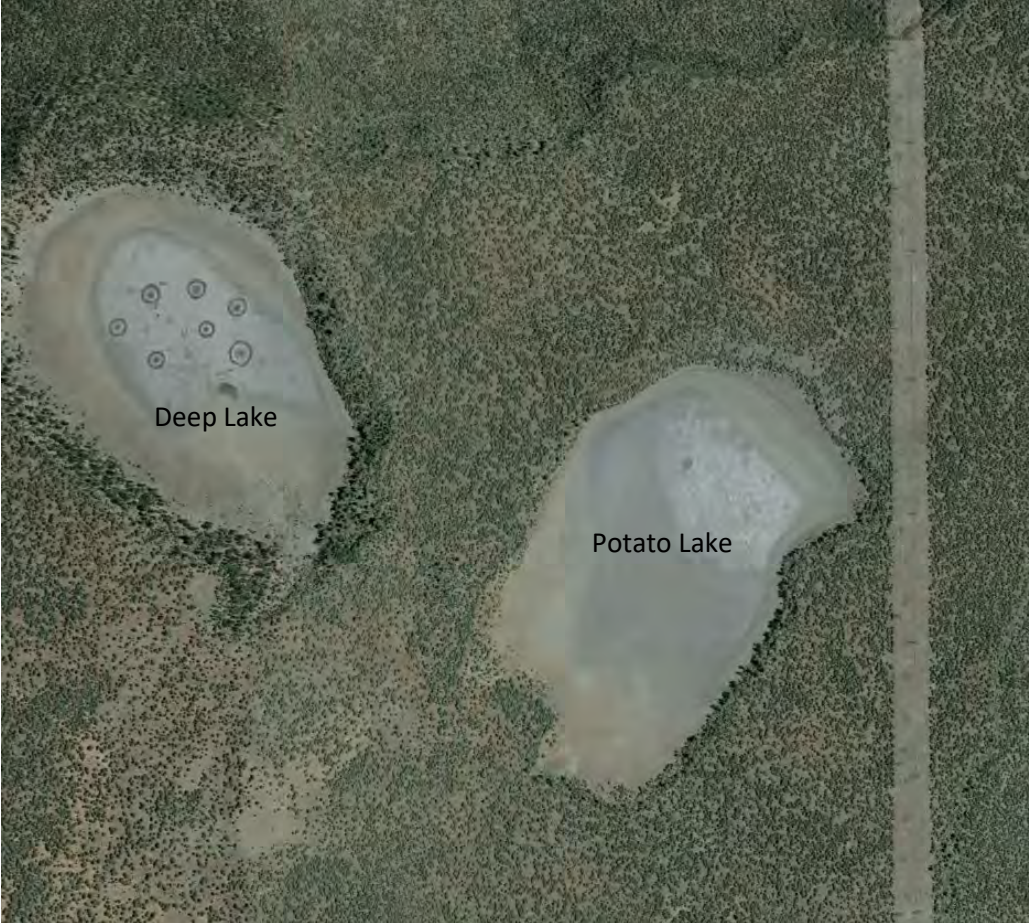
<p>Figure 1. Google Earth Pro Imagery (2021) that shows no outlet from Potato Lake.</p>

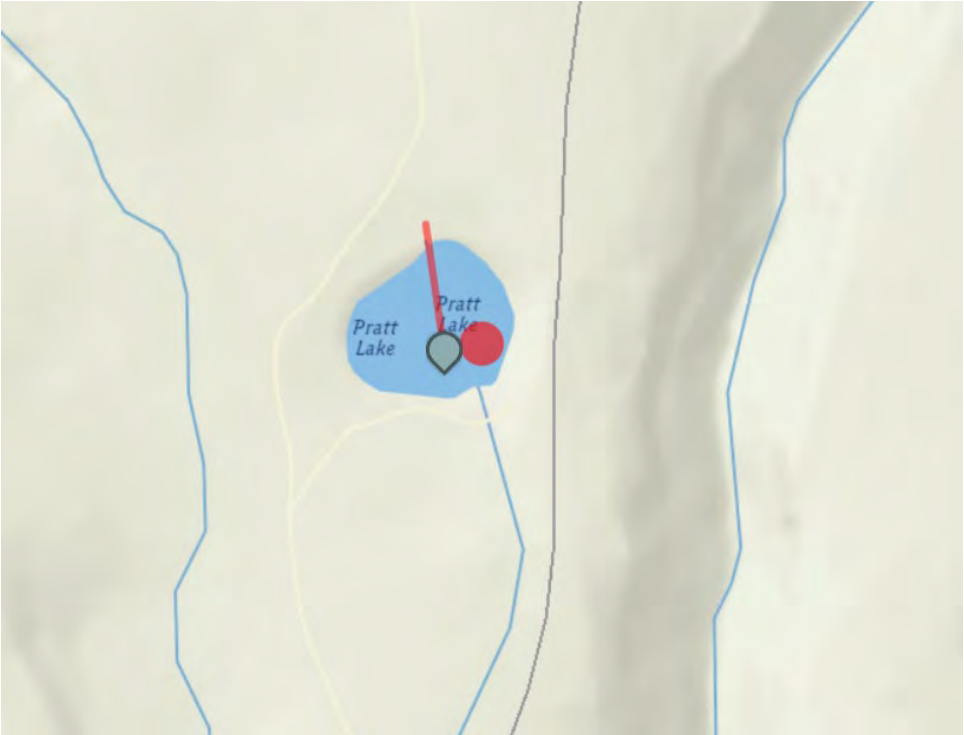
<p>Figure 1. The USGS Raindrop Tool shows no flow path.</p>
